Living Laboratory Study Visit Report

The ASCENT Site

Errigal Mountain Co Donegal, Ireland

Errigal Mountain Living laboratory Study Visit Report : A Practitioners Perspective

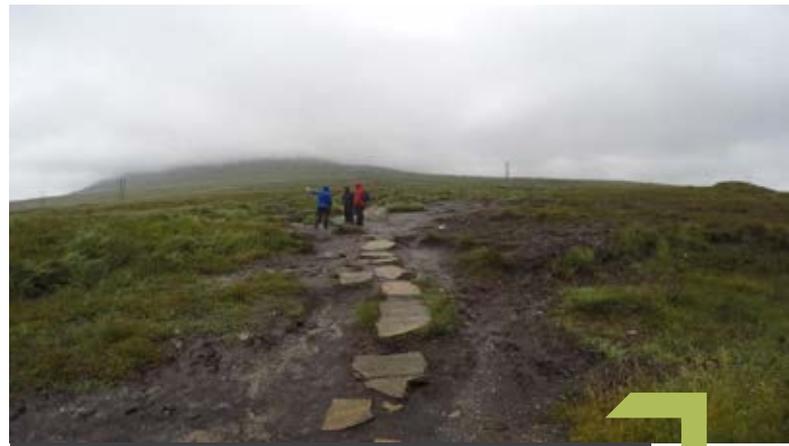
Figure 2: Trail Access from car park to Direct Ascent Route displaying attempts to pave path and erosion damage.

The spread of braiding has also restricted the development of deep peat gullies or exposed aggregate, suggesting that habitat restoration is possible at this level of damage. Attempts to manage the erosion exist, with some paving stones placed near the beginning of the trail, however the lack of natural path materials at this stage (such as natural stone deposits or aggregate) limit endeavours of this kind. No drainage or water bars exist to manage excess moisture.

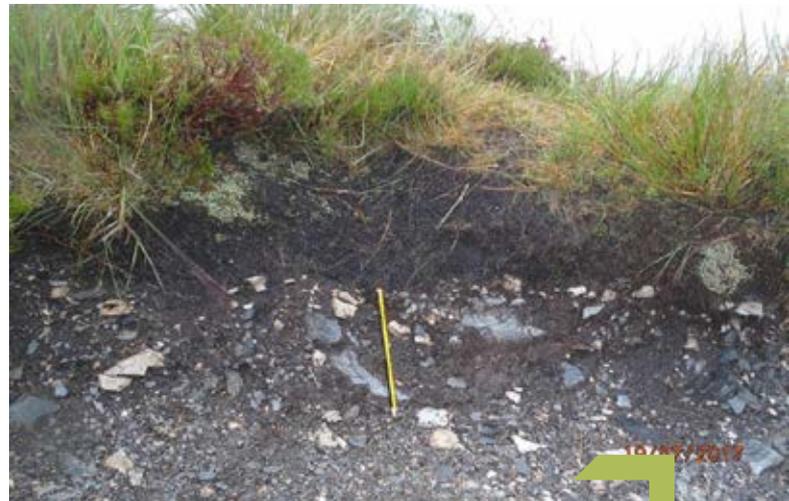
Figure 3: Exposed peat gullies formed by a combination of water and wind erosion. Pencil for scale.

As the route begins to ascend sharply at a $\pm 35^\circ$ gradient, erosion damage is amplified, with deep peat gullies and areas of exposed aggregate demonstrating the combined damage of visitor footfall and unregulated drainage.

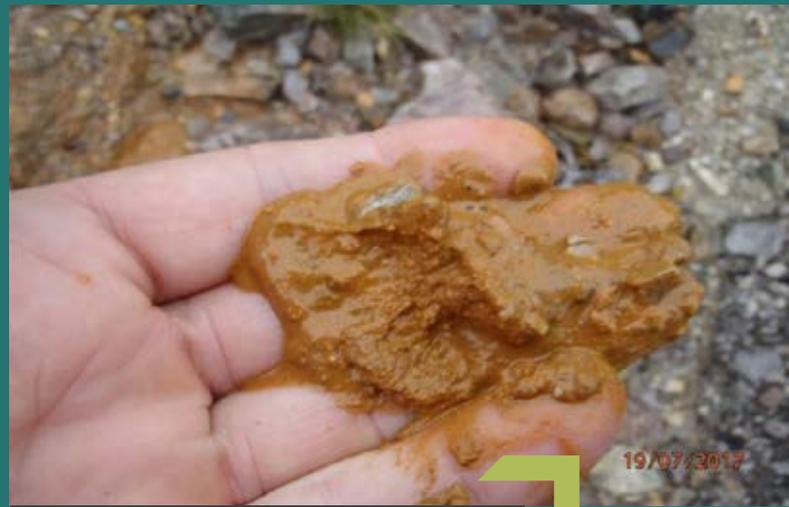
Figure 4: Aggregate comprised of glacial till provides good-quality native path materials.

Exposed bedrock and loose scree stone available in this area are comprised of quartzite, with granitic intrusions which would feasibly be suitable path material. Initial aggregate analysis also suggests that good-quality native path materials comprised of a glacial till, exist to utilise in this area. Higher along the route, glacial till contains clay deposits.

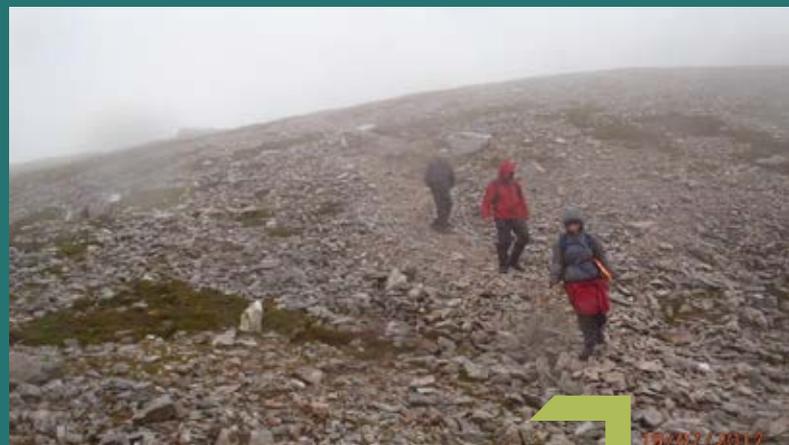
Figure 5: Exposed bedrock and loose scree apparent.

As the route ascends (gradient $\pm 40^\circ$), the slope is comprised of loose scree, with wide areas of erosion where people have moved to avoid the loose stone and no discernible trail. From here to the 200m towards the summit there is a high level of damage, which is unlikely to recover without intervention.

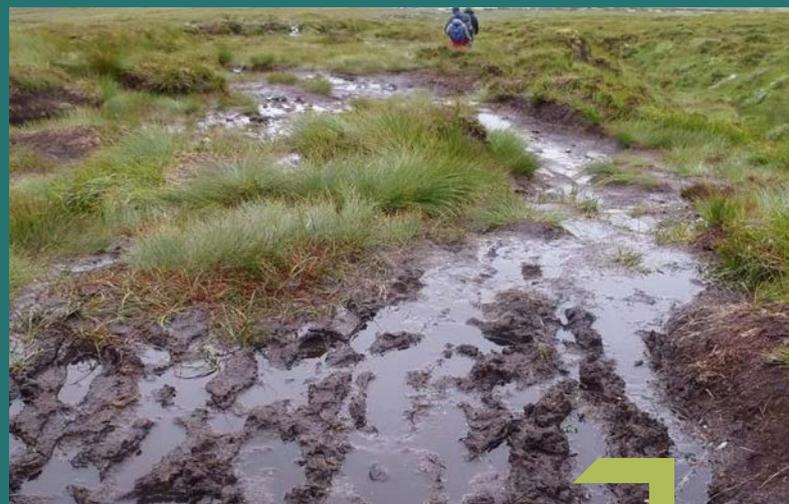
Figure 6: Heavy foot traffic in the first stage of the Stream Side route, leading to habitat damage and wide patches of erosion.

An advantage of this route is its proximity to the stream, which provides natural drainage and makes the land substantially drier to walk on as the route ascends. Additionally, strategically-placed stone cairns, set to guide hikers along this route, provide key feature points through which a trail could be led. However, it may be difficult to encourage hikers to avoid the 'lure' of the direct ascent (as stated by Chris York in the WtT report, 2015), and the trail is longer and less instinctive for those new to the area. Trail developments with this route in mind will therefore need to be sensitively constructed to navigate hikers accurately along this path. However, there is potential to create a scenic, substantial route along this line. The first section of this route displays habitat damage in the form of deep gullies and wide patches of erosion due to heavy usage and the lack of a defined path. The heath/bog habitat is sensitive to usage and would not withstand consistent custom without a robust path in place to contain visitors and to mitigate damage to surrounding areas.

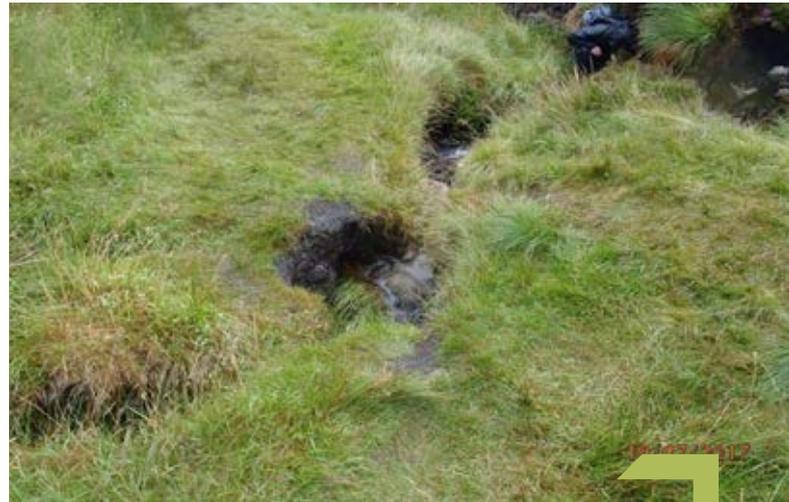
Figure 7: Example of a cross drain found along the Old Route

The old route begins 500m west of the car park, close to Dunlewey town, and bears evidence of former maintenance in the form of cross drains and stone periodic paving. The ground is substantially drier to walk on, with diverse heathland vegetation indicating little damage to the area either due to light past usage or natural restoration once the car park was built. The

line ascends gradually to meet the scree slopes of the direct ascent route. If this line were to be developed, a robust path system would be required to protect the current status of the surrounding habitat, which is sensitive to usage and swift to decline. Old path work can be reinstated and incorporated into new developments to preserve historic heritage of the area.
