Living Laboratory Study Visit Report

Norway 2018

Norway Living Laboratory Study Visit Report: A Practitioners Perspective, 9 - 14 September, 2018

PT1.3 Sharing Path Management Knowledge: Report 4 of 4

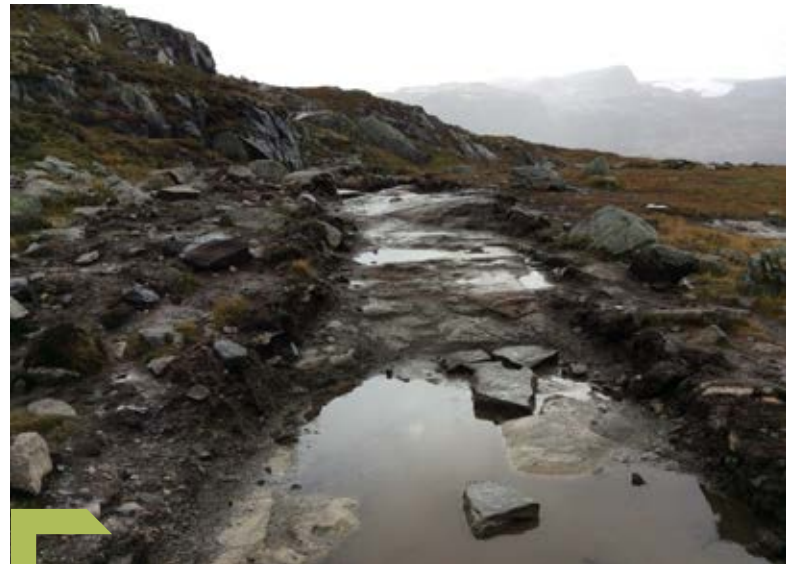
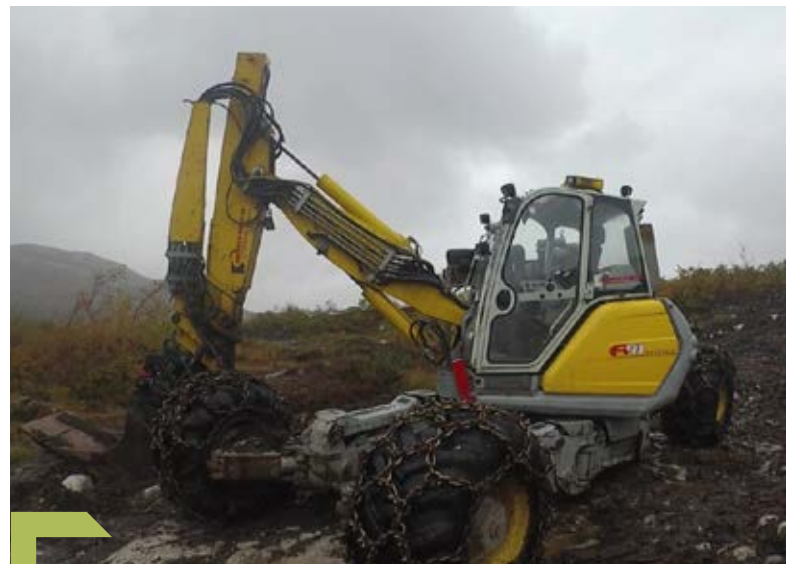
The majority of the work was completed by scraping thin layers of vegetation and top soil from the surface bedrock, which provided a clear, robust path through many kilometres of the walk. The work was primarily carried out by using a 15-tonne walking excavator that, surprisingly, had limited scraping impact on the rocks. The size of rocks that had been moved were evidence of the capabilities of the excavator and the driver. However, it was evident that this approach may result in over-engineering of the route, and could lead to issues that are not apparent now (e.g., that can only be remedied by using the large excavator again). However, this method was beneficial in a number of ways. It was quick to complete within the seasonal constraints of the area, i.e., a small window of opportunity lasting only a few months due to the weather. Also, the exposed rock surface was not susceptible to footfall erosion and the line of the path was easily navigated by inexperienced visitors.

However, this method also displayed limitations. During the site visit, the ASCENT team attempted to mitigate apparent problems with the current Trolltunga path network by using hand tools. It was found that, as the path was the bedrock surface, further infrastructure, such as drainage features, or gradient management, were very difficult to install. In many areas this proved to be problematic as water along stretches of the path surface had caused erosion to either side of the path, where visitors had stepped to avoid puddles. This has the potential to become increasingly problematic in the future, as the restrictive nature of the bedrock path will mean that path repair may require line changes, or additional water management either side of the path. Another path management method implemented at Trolltunga – and throughout Norway – is the use of stone waypoints as a means of highlighting the route to visitors. Norwegian Trekking Association’s ‘red T’ way marker design, is also used consistently across the country to highlight routes. The combination of these methods served to keep travellers on route to Trolltunga, particularly in areas where path work was difficult to implement, such as large areas of bare bedrock.

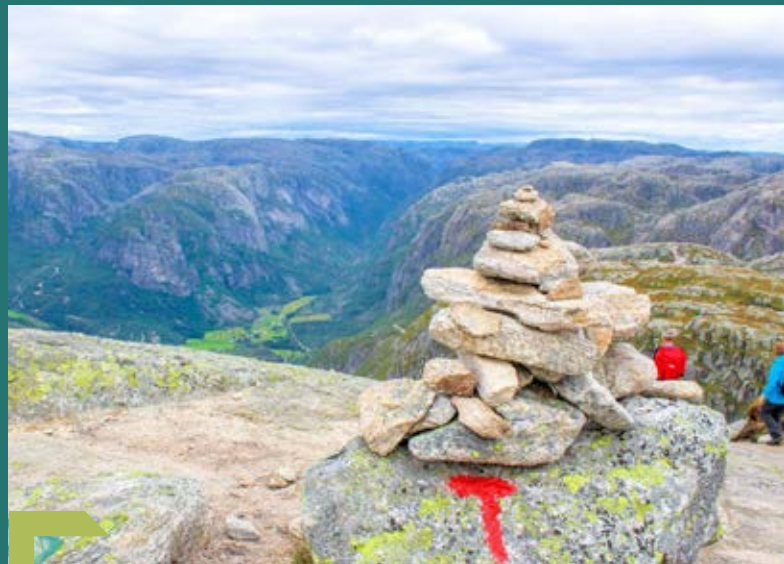
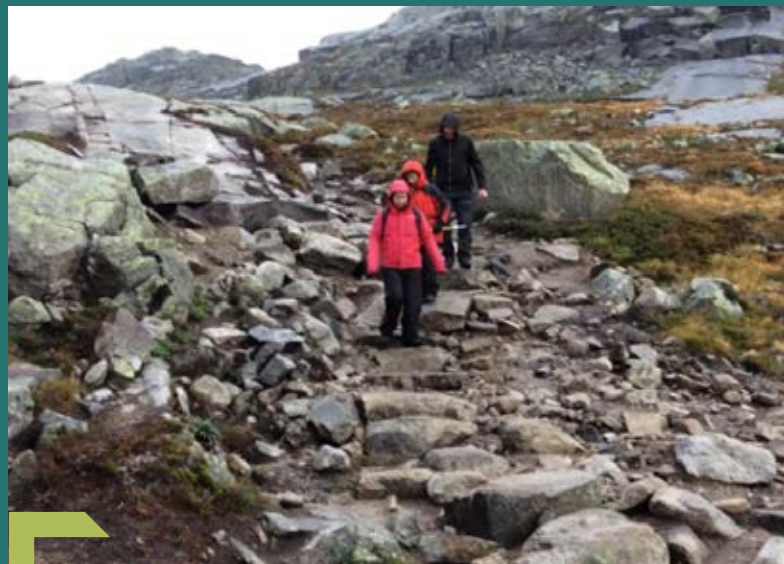
Steeper parts of the route were comprised of granite stone steps, which were effective in keeping travellers within the path line. It was noted, however, that more could be done to landscape the staircase in order to blend the work back into the surrounding area.

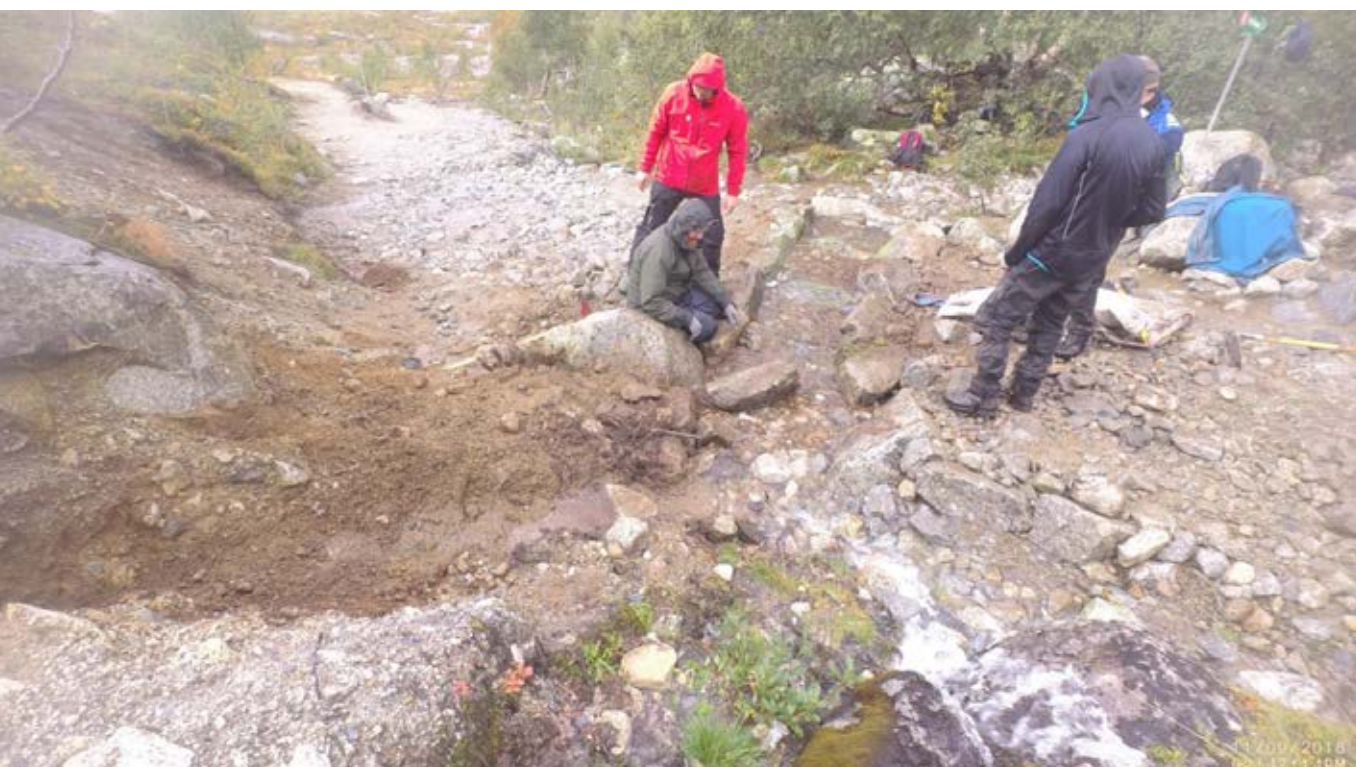
The work was completed by the use of hand tools, mainly crescent hoes, spades and pinch bars, and involved manipulating native stone and aggregate in situ to form path infrastructure.

The techniques demonstrated commonly-used path work methods, showcasing the capacity for using on-site materials and low-impact hand work to achieve sustainable path structures. A cross drain was built near the source of a heavy flow of surface water, which came from snow melt and rainfall running from the steep hillside above onto the path below. Water was channelled into the cross drain to prevent washout of path materials and to encourage users to stay on the path. Approximately 30 metres further up the path, above the cross drain, and on a steeper gradient, control measures were demonstrated, using stone steps to replace a gravel ramp to allow walkers to traverse the steeper area more easily, and also to prevent material loss from washout.
